OHIO RIVER BASIN  
SHENANGO RIVER, CRAWFORD COUNTY  
PENNSYLVANIA

NDI No. Pa. - 176  
PYMATUNING RESERVOIR

PHASE I INSPECTION REPORT  
NATIONAL DAM INSPECTION PROGRAM,

11 AUGUST 1978

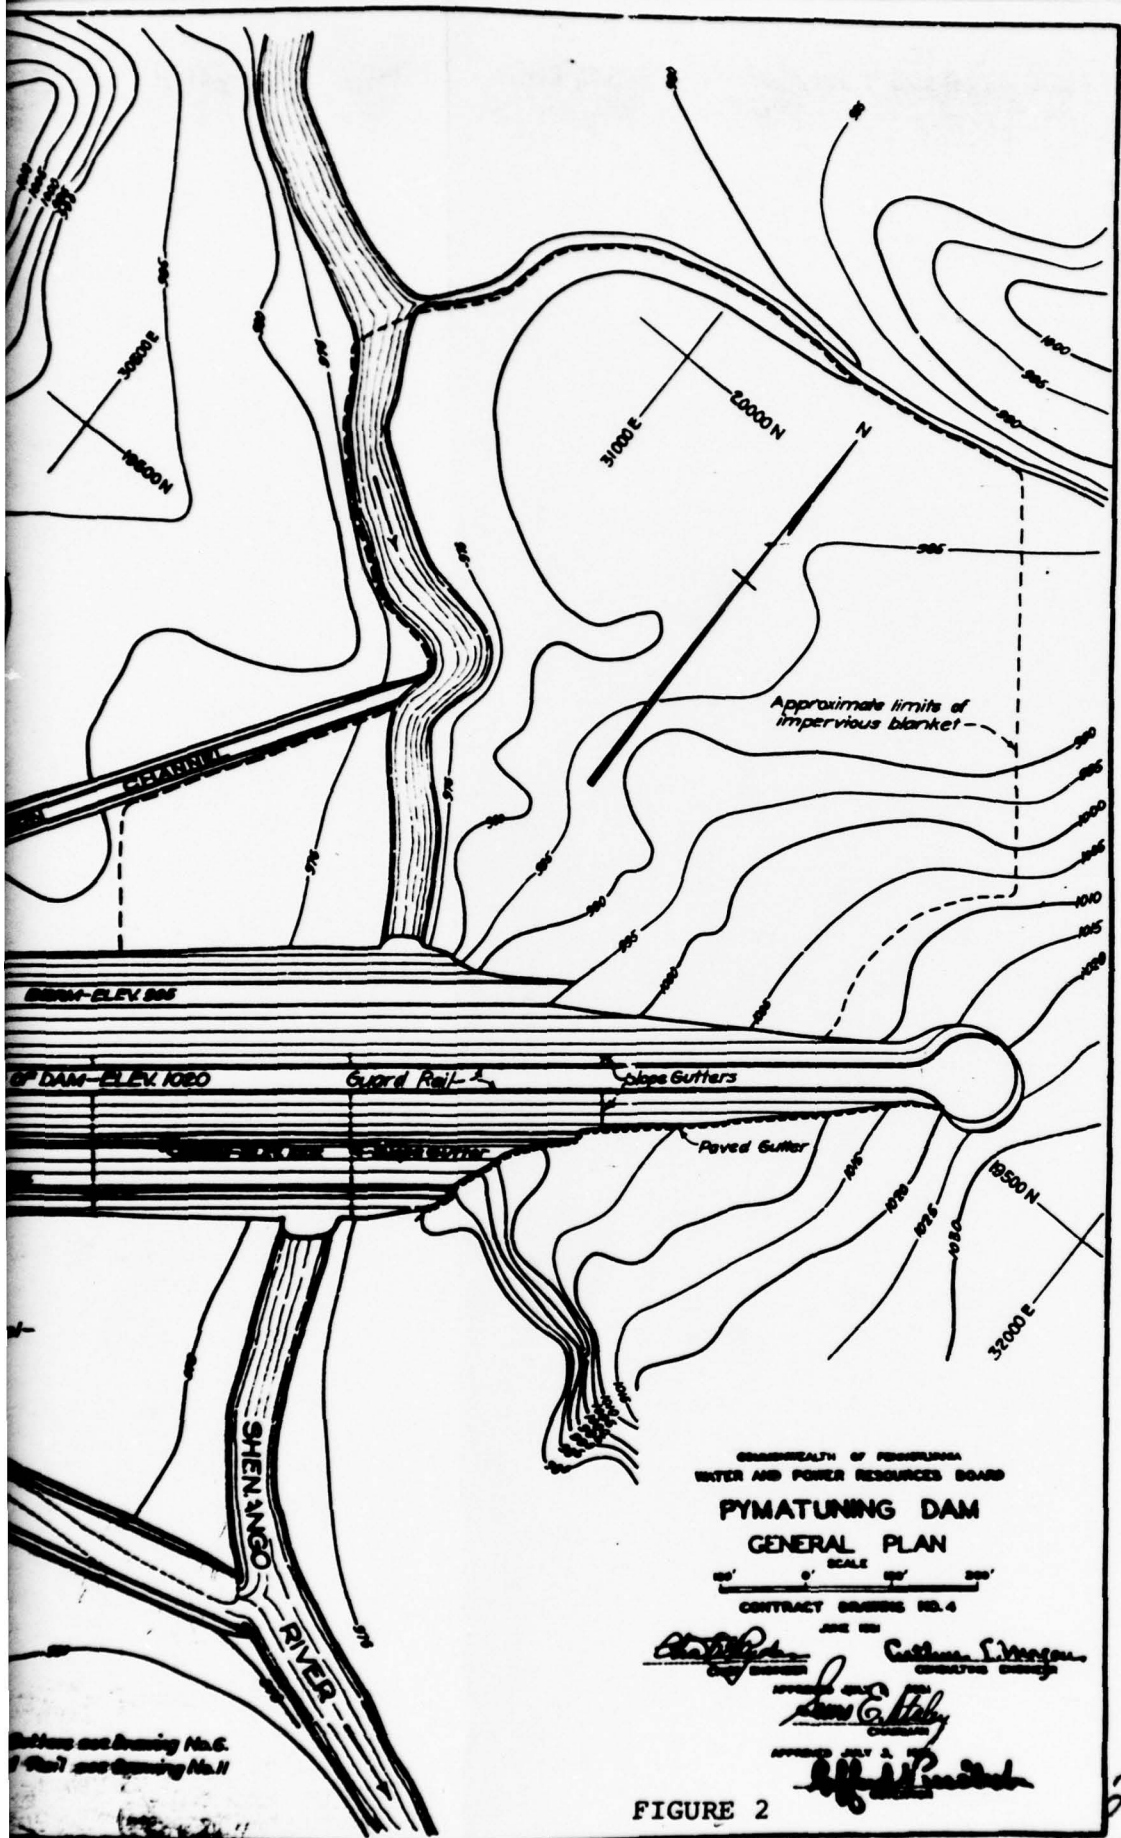
FIGURE 2

Cutoff - Available drawings indicate a cutoff trench was excavated along the centerline of the dam and backfilled with impervious material. Beyond the trench, steel sheetpiling was apparently driven to rock beneath that portion of the dam to the west of the original Shenango River Channel. To the east of the original Shenango River channel, sheetpiling was driven to depth of approximately 60 feet (not to the top of rock), as shown in Figure 3. Upstream of the sheetpiling in this area, a rolled fill impervious blanket was placed for a distance of approximately 800 feet in an apparent attempt to reduce the seepage losses beneath the dam in this area. (see Figure 2)

Interlocking sheetpiling was reportedly driven to rock, within a cutoff trench, west of old Shenango River channel. To the east, the sheetpiling was driven to an average depth of 60 feet and an impervious blanket was provided upstream of the dam in an attempt to reduce seepage losses in this area (see Figure 2).

A swampy area is located beyond the toe of the dam over the left portion of the downstream valley (see Photographs 1 and 3). The swamp is situated at the approximate location of the old Shenango River channel as shown on Figure 2 and affects a triangular surface area with a base (along the toe of the dam) of about 500 feet and a depth (measured perpendicular to the base toward the stream channel) of 300 feet. Flow from the swamp is directed via a partially obstructed drainage ditch into the Shenango River just downstream of a gaging station (U.S.G.S. gaging station 300 feet downstream of dam) on the Shenango River outlet channel. Total discharge at this point on the day of inspection was estimated to be less than 5 gpm.

Two areas of seepage were found associated with the embankment. The first was noted to the right of the discharge end of the primary outlet structure (see Photographs 5 and 6). Seepage in this area was minimal and may be associated with tile drains which apparently drain the parking area atop the dam (see Figure 2).

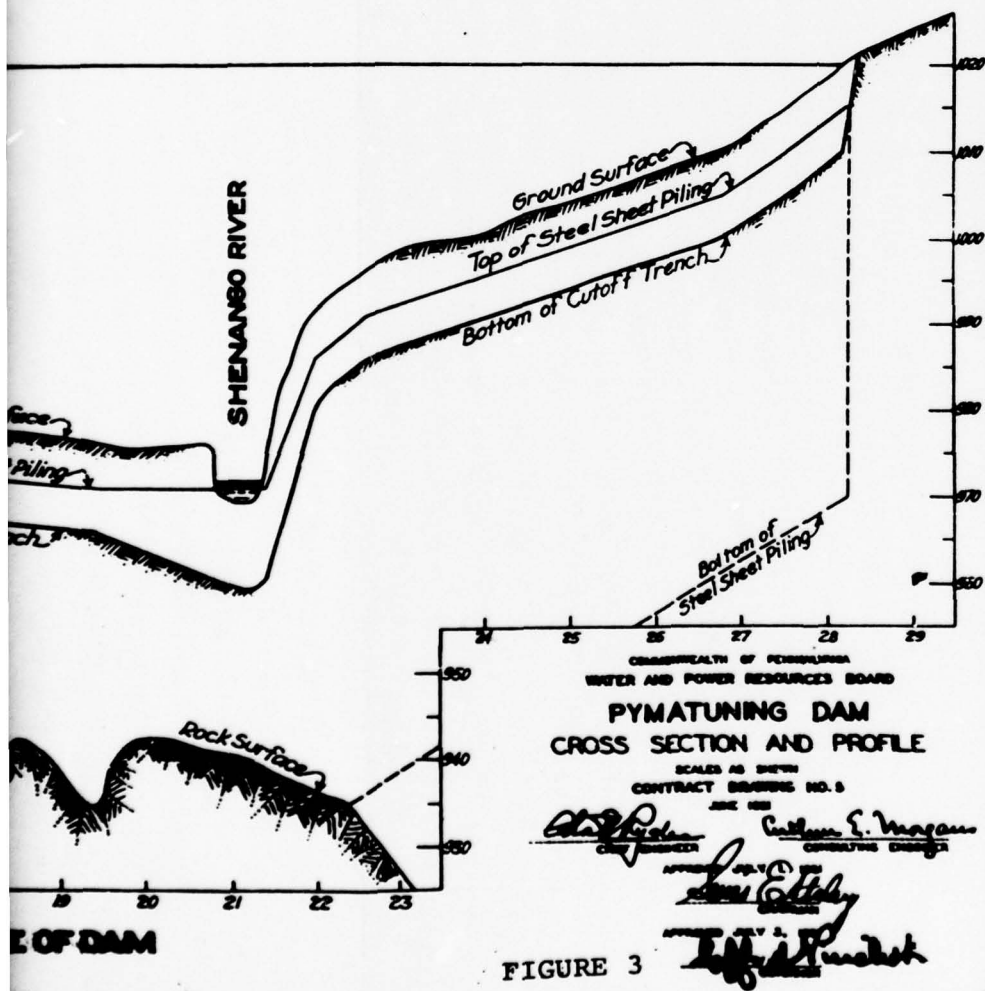
FIGURE 3

Zoning - Available drawings indicate the embankment is composed of either rolled or semi-hydraulic fill. Hand placed riprap covers the upstream slope between elevations 995 and 1016. A coarse gravel drain is located at the toe of the dam (see Figure 3) in the valley where the embankment height is greatest.

b. Design Features. Pre-construction drawings and other files indicate that the dam is a zoned earth embankment. Portions of the embankment and an upstream impervious blanket were constructed of rolled earth as shown on Figure 3. It is not known, however, if the main portion of the embankment was constructed of rolled fill or semi-hydraulic fill. In any case, the specifications state that "the outer portion of the dam shall be composed of coarse material which shall be permanently stable under a condition of complete saturation. The center portion of the dam shall be composed of material containing sufficient clay or other finely divided particles to be highly impervious to water".

The downstream slope of Pymatuning Dam is grass covered. Slopes are 2.5H to 1V between elevations 1002 and 1020 and are 3H to 1V below elevation 1002. Two ten-foot wide berms are located at elevations 1002 and 984 on the downstream dam face. The upstream slope is riprap covered between elevations 995 and 1016. Details of the upstream slope are shown on Figure 3.
